**Vermont Electric Cooperative, Inc.**

**Vermont PUC Rule 4.900**

**2023 Electricity Outage Report**

**January 31, 2024**

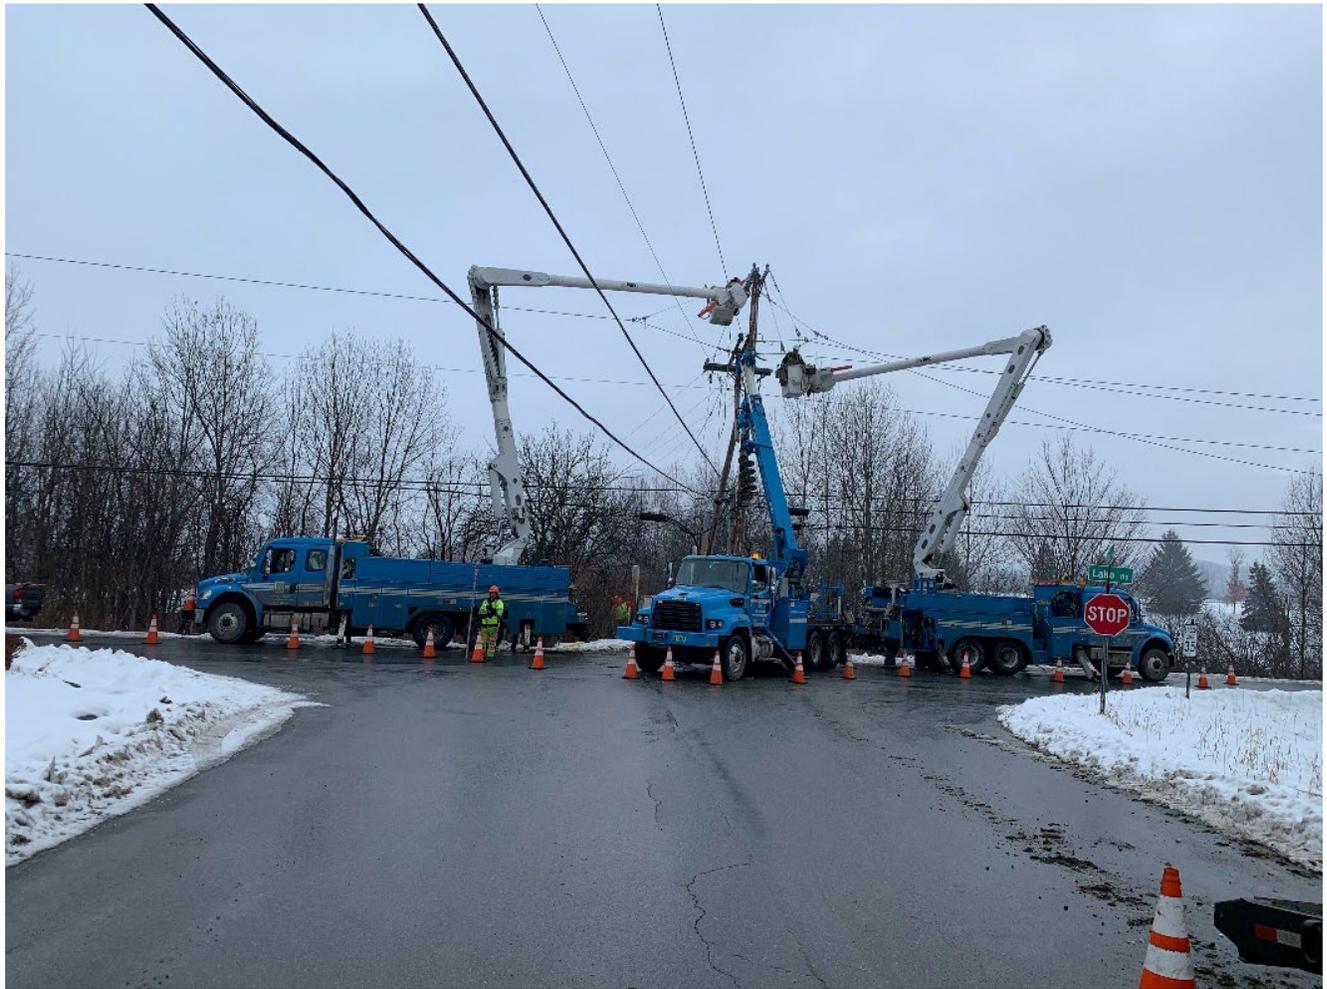
The number of car-pole accidents decreased significantly, whereas the number of customer hours out due to such accidents decreased in 2023. The nature and location of these accidents has a significant impact on the duration of car pole outages. A picture of a three-phase car pole accident are included after the chart below.

Example of VEC Line Crews repairing a car pole accident.
